MECHANICAL FAILURE PROGNOSIS THROUGH  
OIL DEBRIS MONITORING

Exxon Research and Engineering  
Company

Army Air Mobility Research and  
Development Laboratory

January 1975

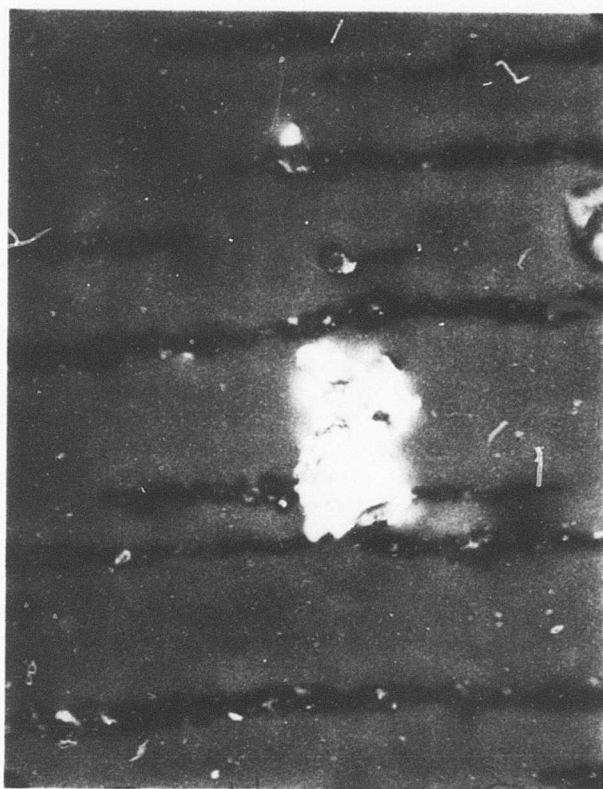
Figure 6. High-Cycle Sliding Fatigue Particles.

3.1.1 High-Cycle Sliding Fatigue is characterized by failures which appear to be individual grains popped out of the surface. These have been identified by Trans-Sonics (13) and an example is shown in Figure 6.

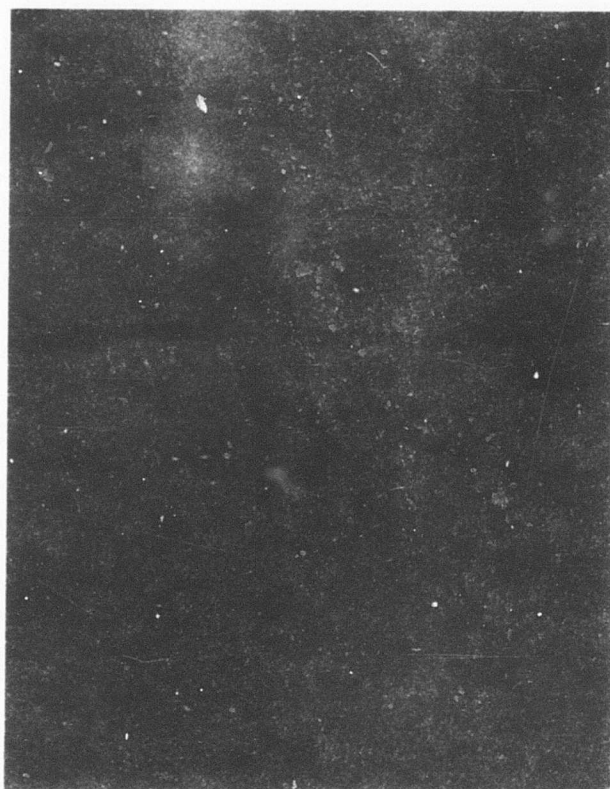
Figure 8. Low-Cycle Sliding Fatigue Particles.

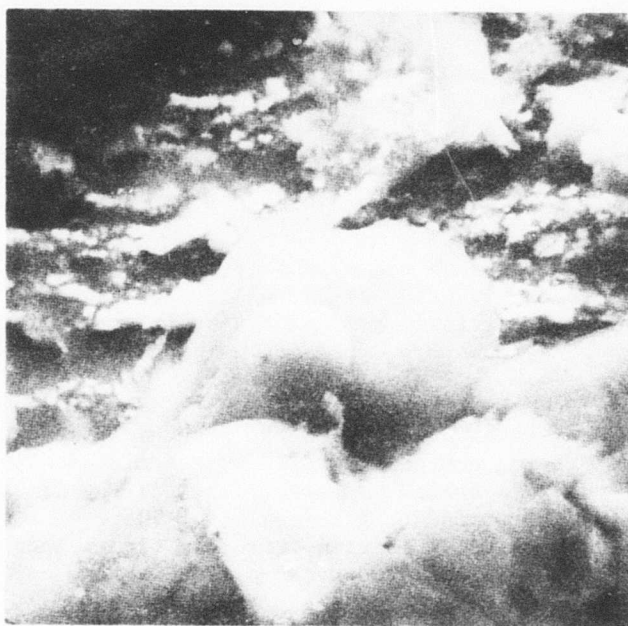
Figure 9. Spherical Particles from Rolling Fatigue (36).

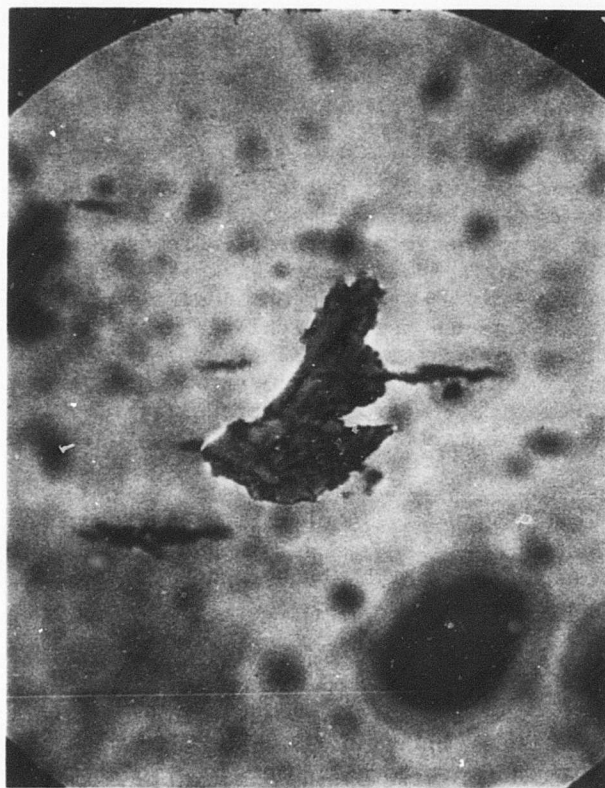
Figure 10. Particles from Scuffing Wear.

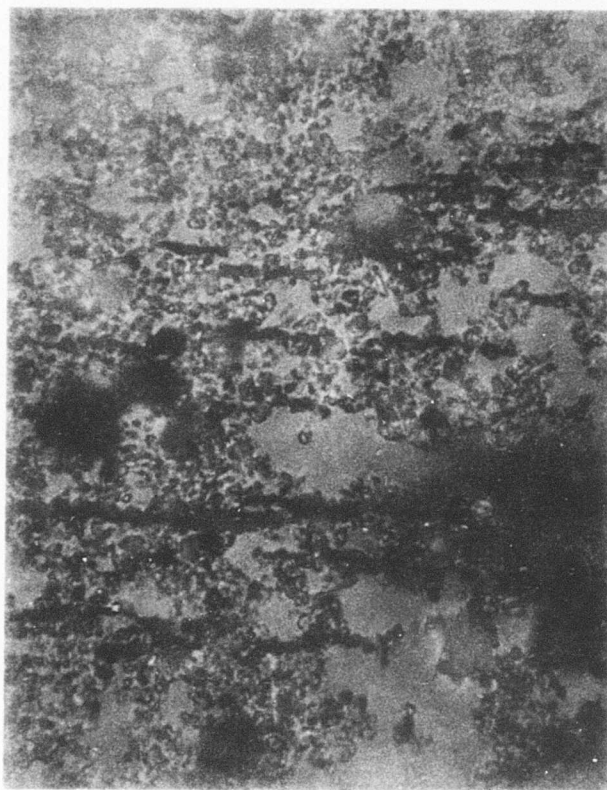
Figure 11. Particles from Corrosive Wear (13).

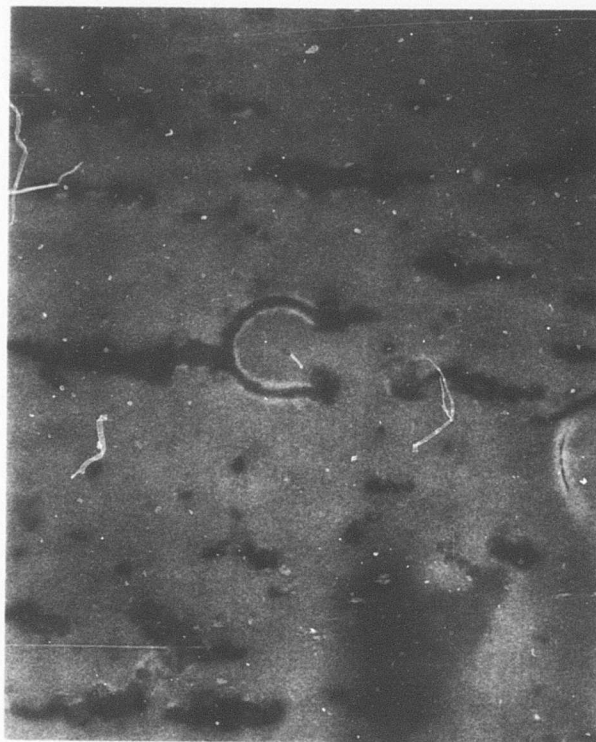
Figure 12. Particles from Abrasive Cutting Wear (13).

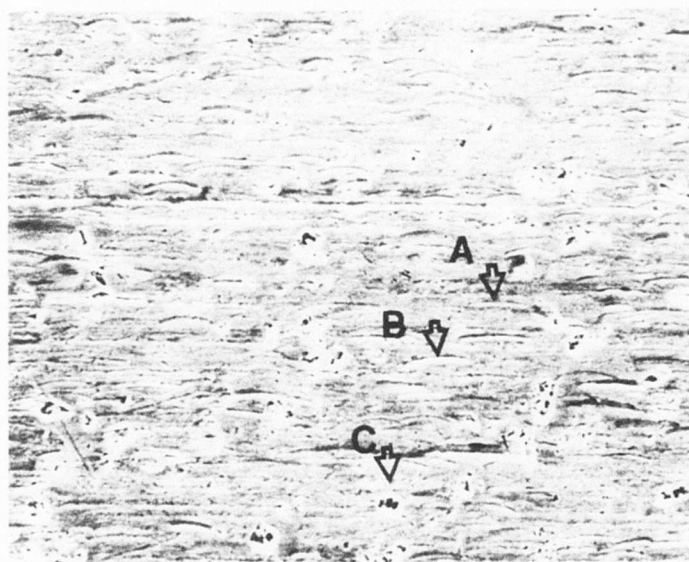
Figure 23. SEM Microgram (1000X) Showing Kinematic Wear Marks.

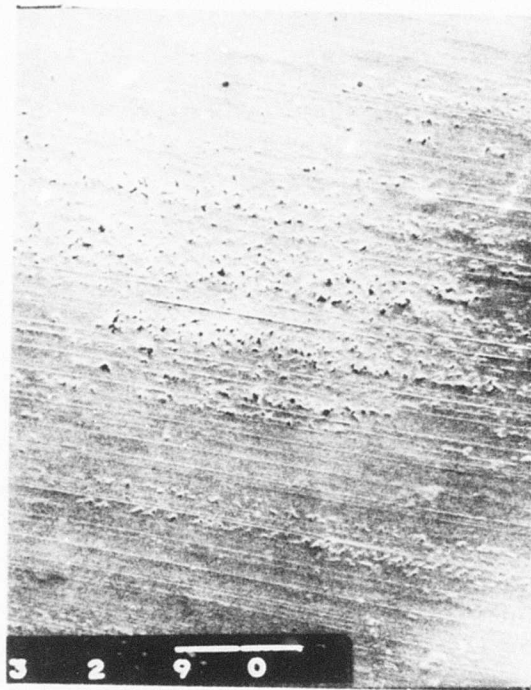
Figure 28. Optical Microgram (50X) of Advanced Surface Distress.

Figure 28 is a higher magnification photograph of a heavily glazed surface with bands of surface microspalls, and Figure 29 is an SEM microgram

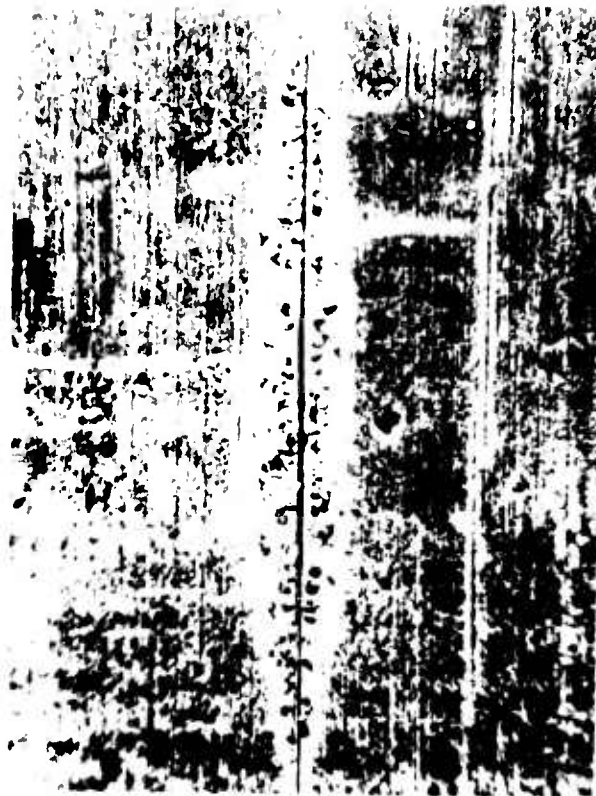
Figure 30. Optical Microgram (85X) of Local Surface Distress.

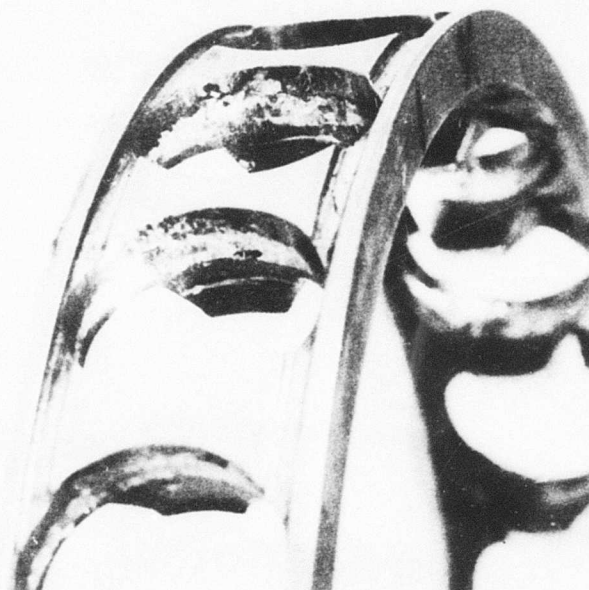
Figure 32. Cage Smearing.

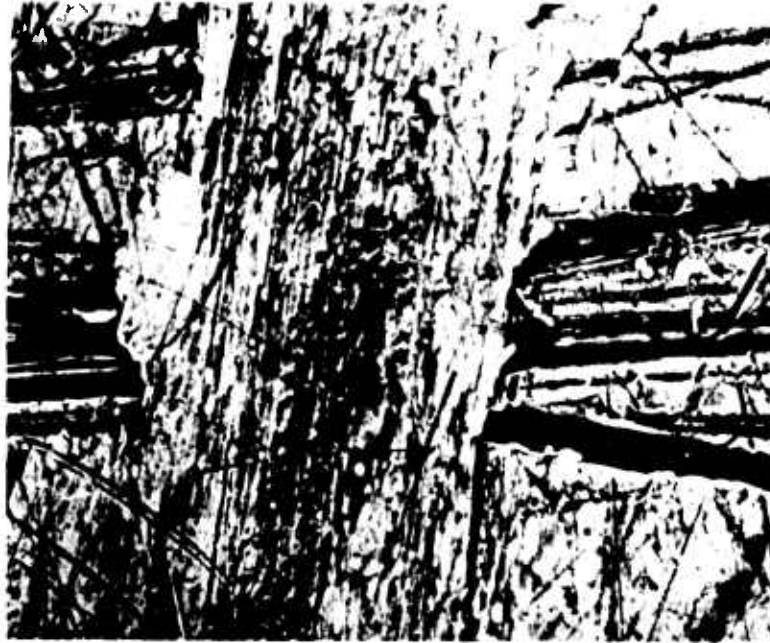
Figure 33. SEM Microgram (500X) Showing Smeared Surface.

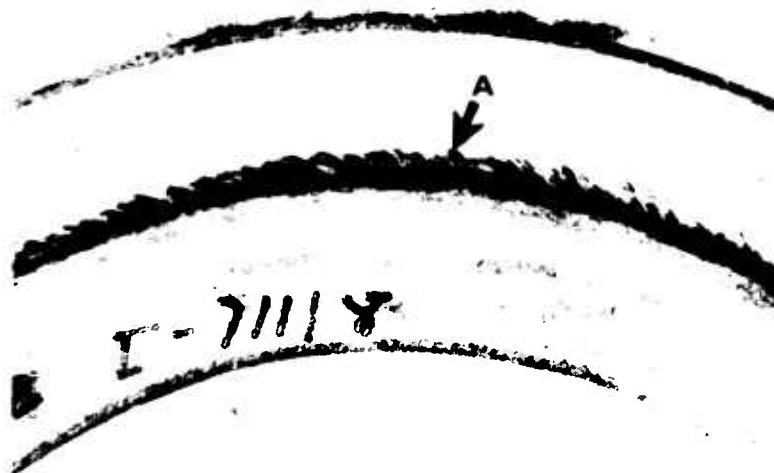
Figure 34. Smearing in Ball Thrust Bearing. (4X)

consist of transferred metal. Smeared metal can appear either dark or light against the unsmeared background, depending on illumination.

Smearing in the race of a ball thrust bearing in which sliding as well as rolling occurs from the ball spinning motion is shown in Figure 34. The dark appearing diagonal hatchmarks or streaks in the groove (A)

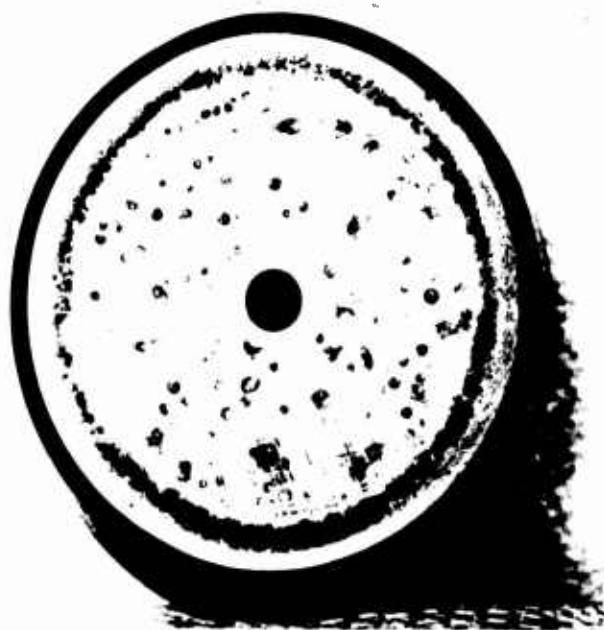
Figure 36. Corrosion on End of Roller. (2X)

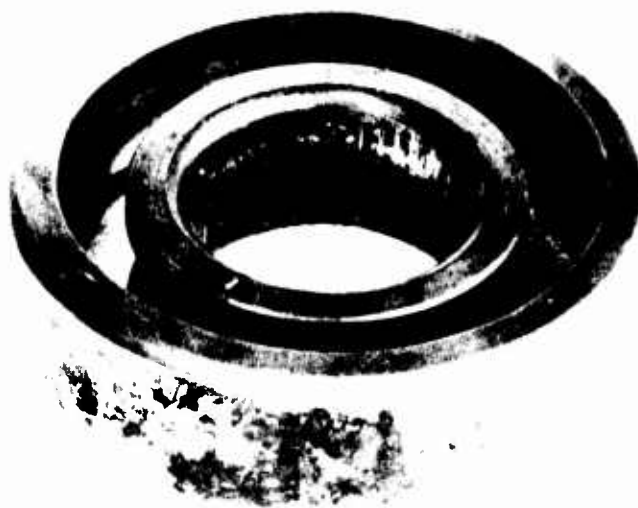
Figure 39. Wear Due to Fretting Corrosion. (.75X)
